Air Coupled Acoustic Thermography

Nondestructive evaluation and inspection of
honeycomb structures

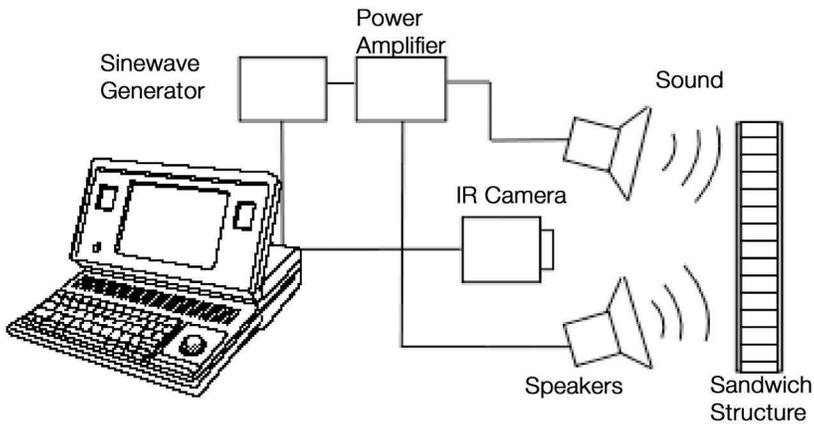
ACAT system block diagram for noncontact inspection of honeycomb structures

ACAT consists of an infrared camera, an image data capture system, an acoustic excitation source, and a chamber. The structure of interest is placed in a chamber to contain the sound and create a stable thermal environment. A loudspeaker is placed near to, but not in contact with, the structure, and it is then pulsed with acoustic energy for approximately 4080 cycles. The majority of the acoustic excitation is reflected off the structure, and very little energy absorption is observed. However, weak or damaged areas vibrate and act like heat sources. These heat sources can then be visualized using an infrared camera. A typical inspection time takes 23 minutes. The data is processed pixel by pixel in the time domain using a fast Fourier transform algorithm to produce a magnitude of images as a function of frequency. ACAT can visualize core and near skin structure damage over wide areas without the need for a couplant. This permits ACAT to identify damage in curved and linear structures.

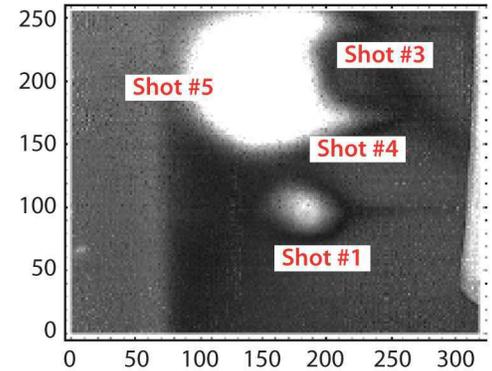
Acoustic Thermography Image (magnitude image at 0.0625 Hz)
